## Renovation of bridge columns with S&P ARMO system

Project: Schneggen bridge (*Schneggenbrücke*) in Glattfelden, Switzerland (ZH/CH)

Year: 2011

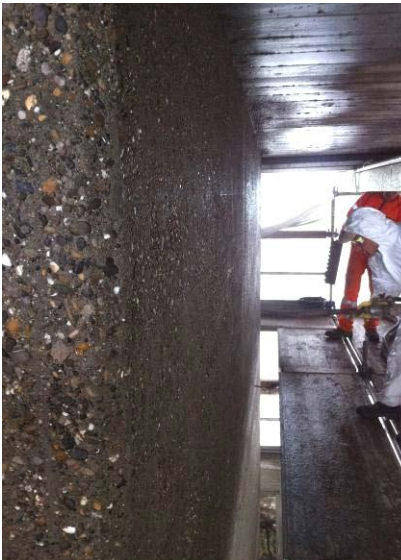
a)

Images: *a) The substrate after preparation for first mortar coat  
b) Incorporation of the ARMO-mesh L200 horizontally into the still-fresh mortar (in strips)  
c) After the application of the second layer of S&P ARMO-crete w RQ*

Solution: Some of the concrete surface was grinded off and the edges were rounded off. Damaged concrete parts were rounded off. After wetting the concrete to capillary saturation, the first layer of S&P ARMO-crete w RQ was applied. The ARMO-mesh L200 (carbon fibres in the horizontal direction) was then pressed into the freshly applied mortar. Next, the second layer of ARMO-crete w RQ was applied using the wet-in-wet method, troweled off, and ground to the desired smoothness. A protective coat was applied, thus completing the reinforcement.
